**FINAL  
SECOND 5-YEAR REVIEW REPORT**

**FOR  
KOPPERS COMPANY, INC.  
SUPERFUND SITE  
OROVILLE, CALIFORNIA**

**February 2003**

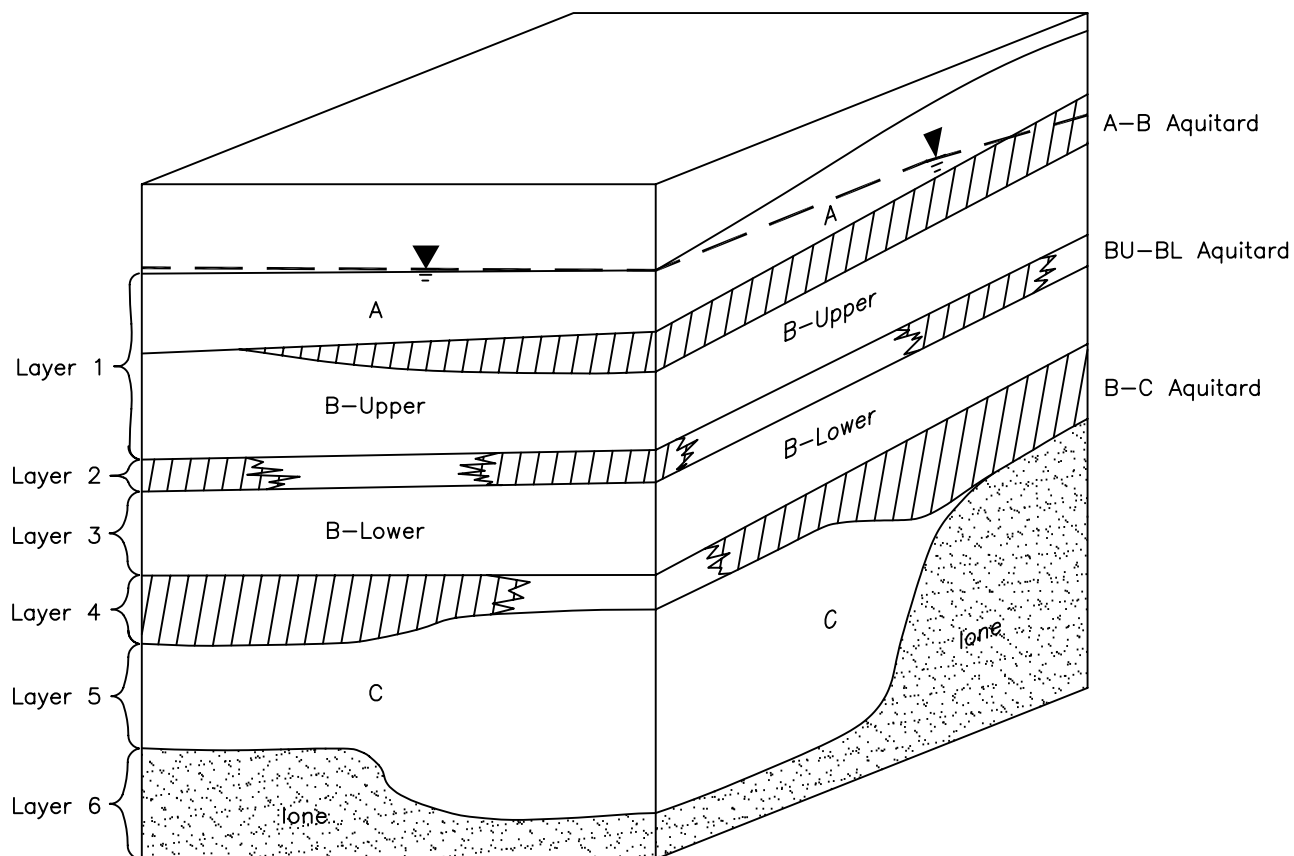
Figure 3  
Hydrostratigraphic  
Block Diagram

Figure Based on: Dames & Moore, 100% Design Report Initial Phase On-Property Groundwater Remediation System, July 1993

The regional A-zone aquifer is above the water table on property and, thus, is not present as an aquifer unit. The A-zone aquifer is noted south of the property within the gravel layer of the Laguna Formation. The B-zone aquifer is subdivided into the upper B and lower B, due to discontinuous shallow clay ranging from 50 to 80 feet bgs. The B and C aquifers are divided by a discontinuous middle clay zone at approximately 125 feet bgs, and the C aquifer extends to the irregular discontinuous Ione Formation silty clay layer at approximately 165 feet bgs. Interbedded clays within the Laguna and Mehrten Formations form discontinuous aquitards and create confining conditions. On a sitewide scale, the upper B, lower B, and C aquifers are interconnected; however, in some portions of the Site, they are locally vertically separated by competent clay layers (HSI Geo Trans, 1999b; see Figure 3).

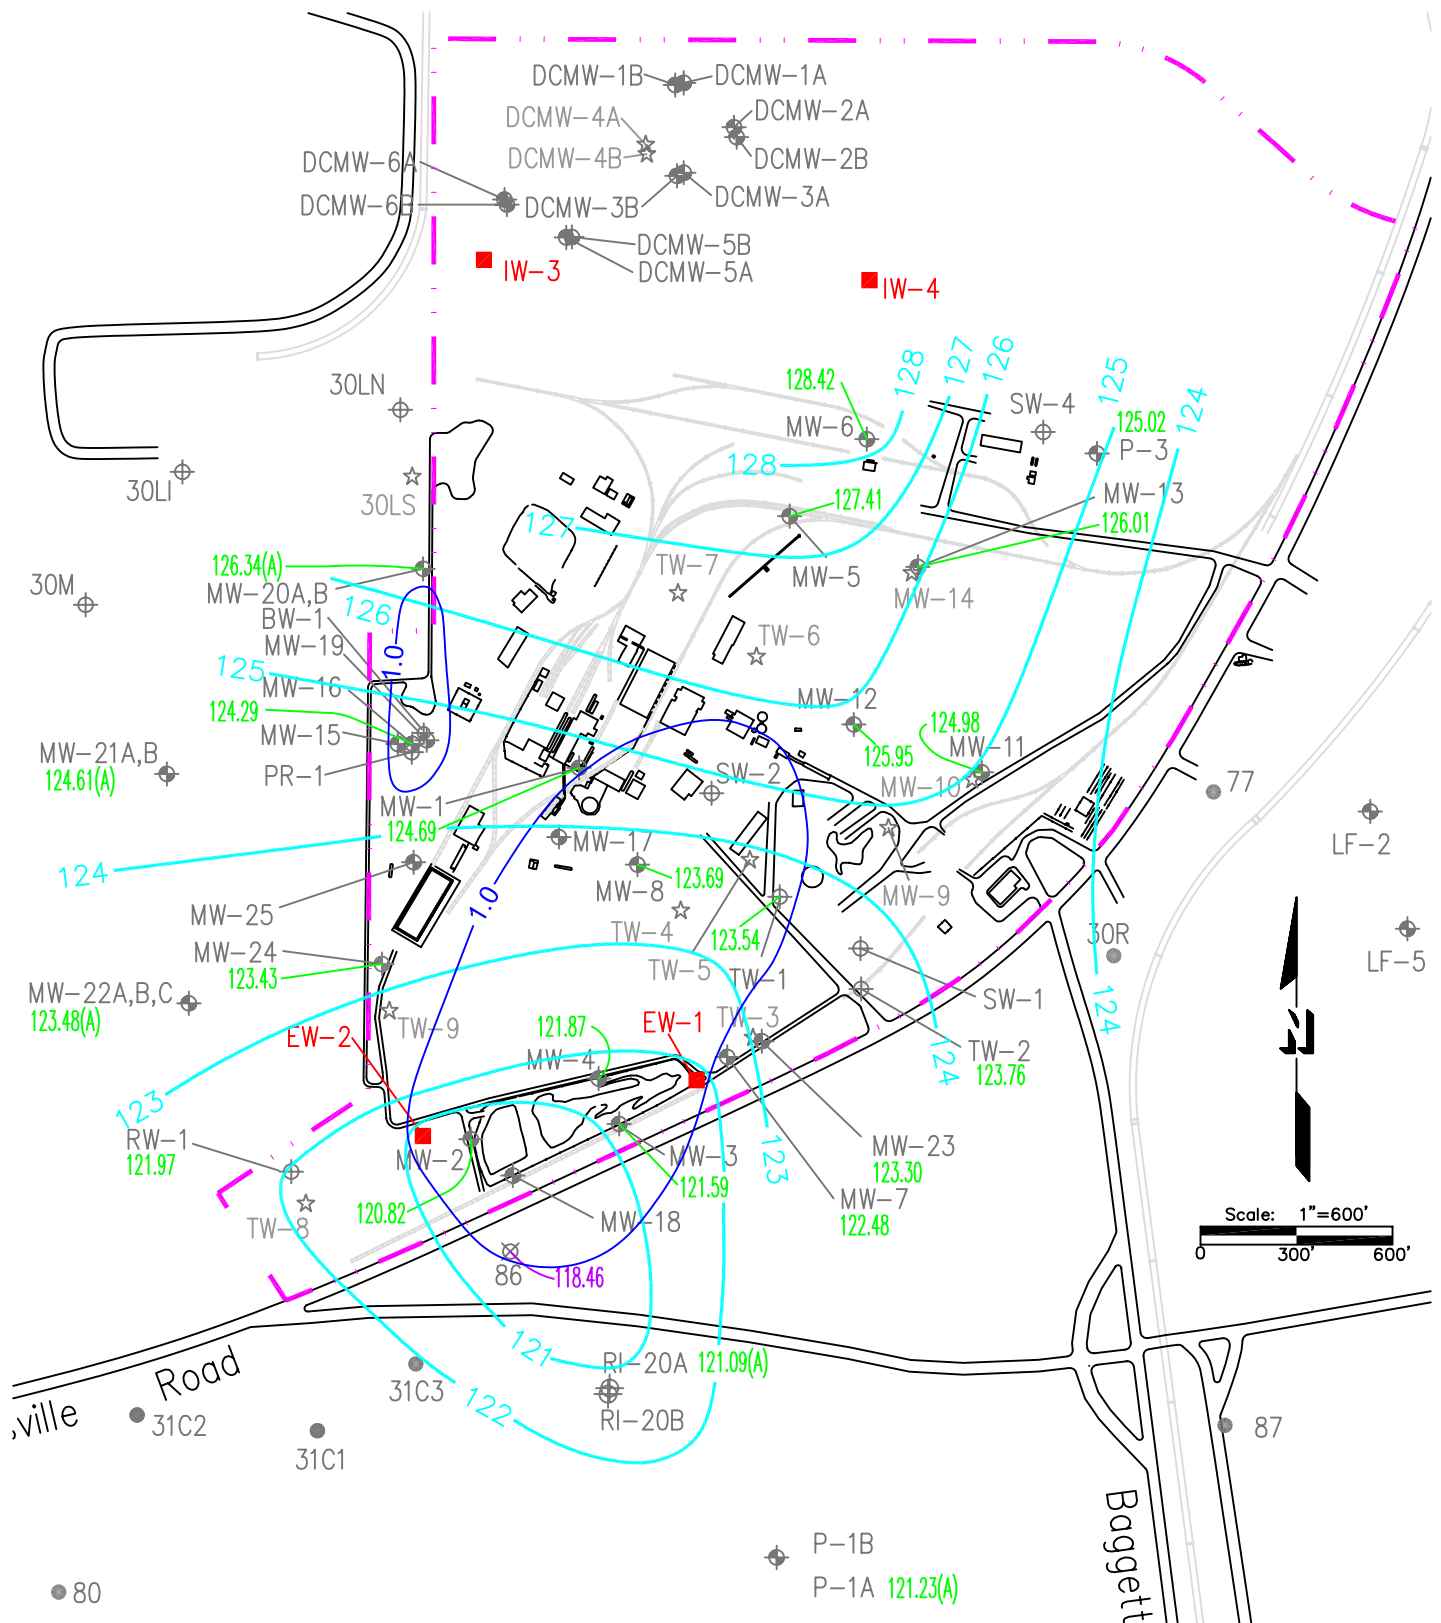
On-Property Groundwater Contours  
June 2002

Source: GeoTrans, 8-20-02

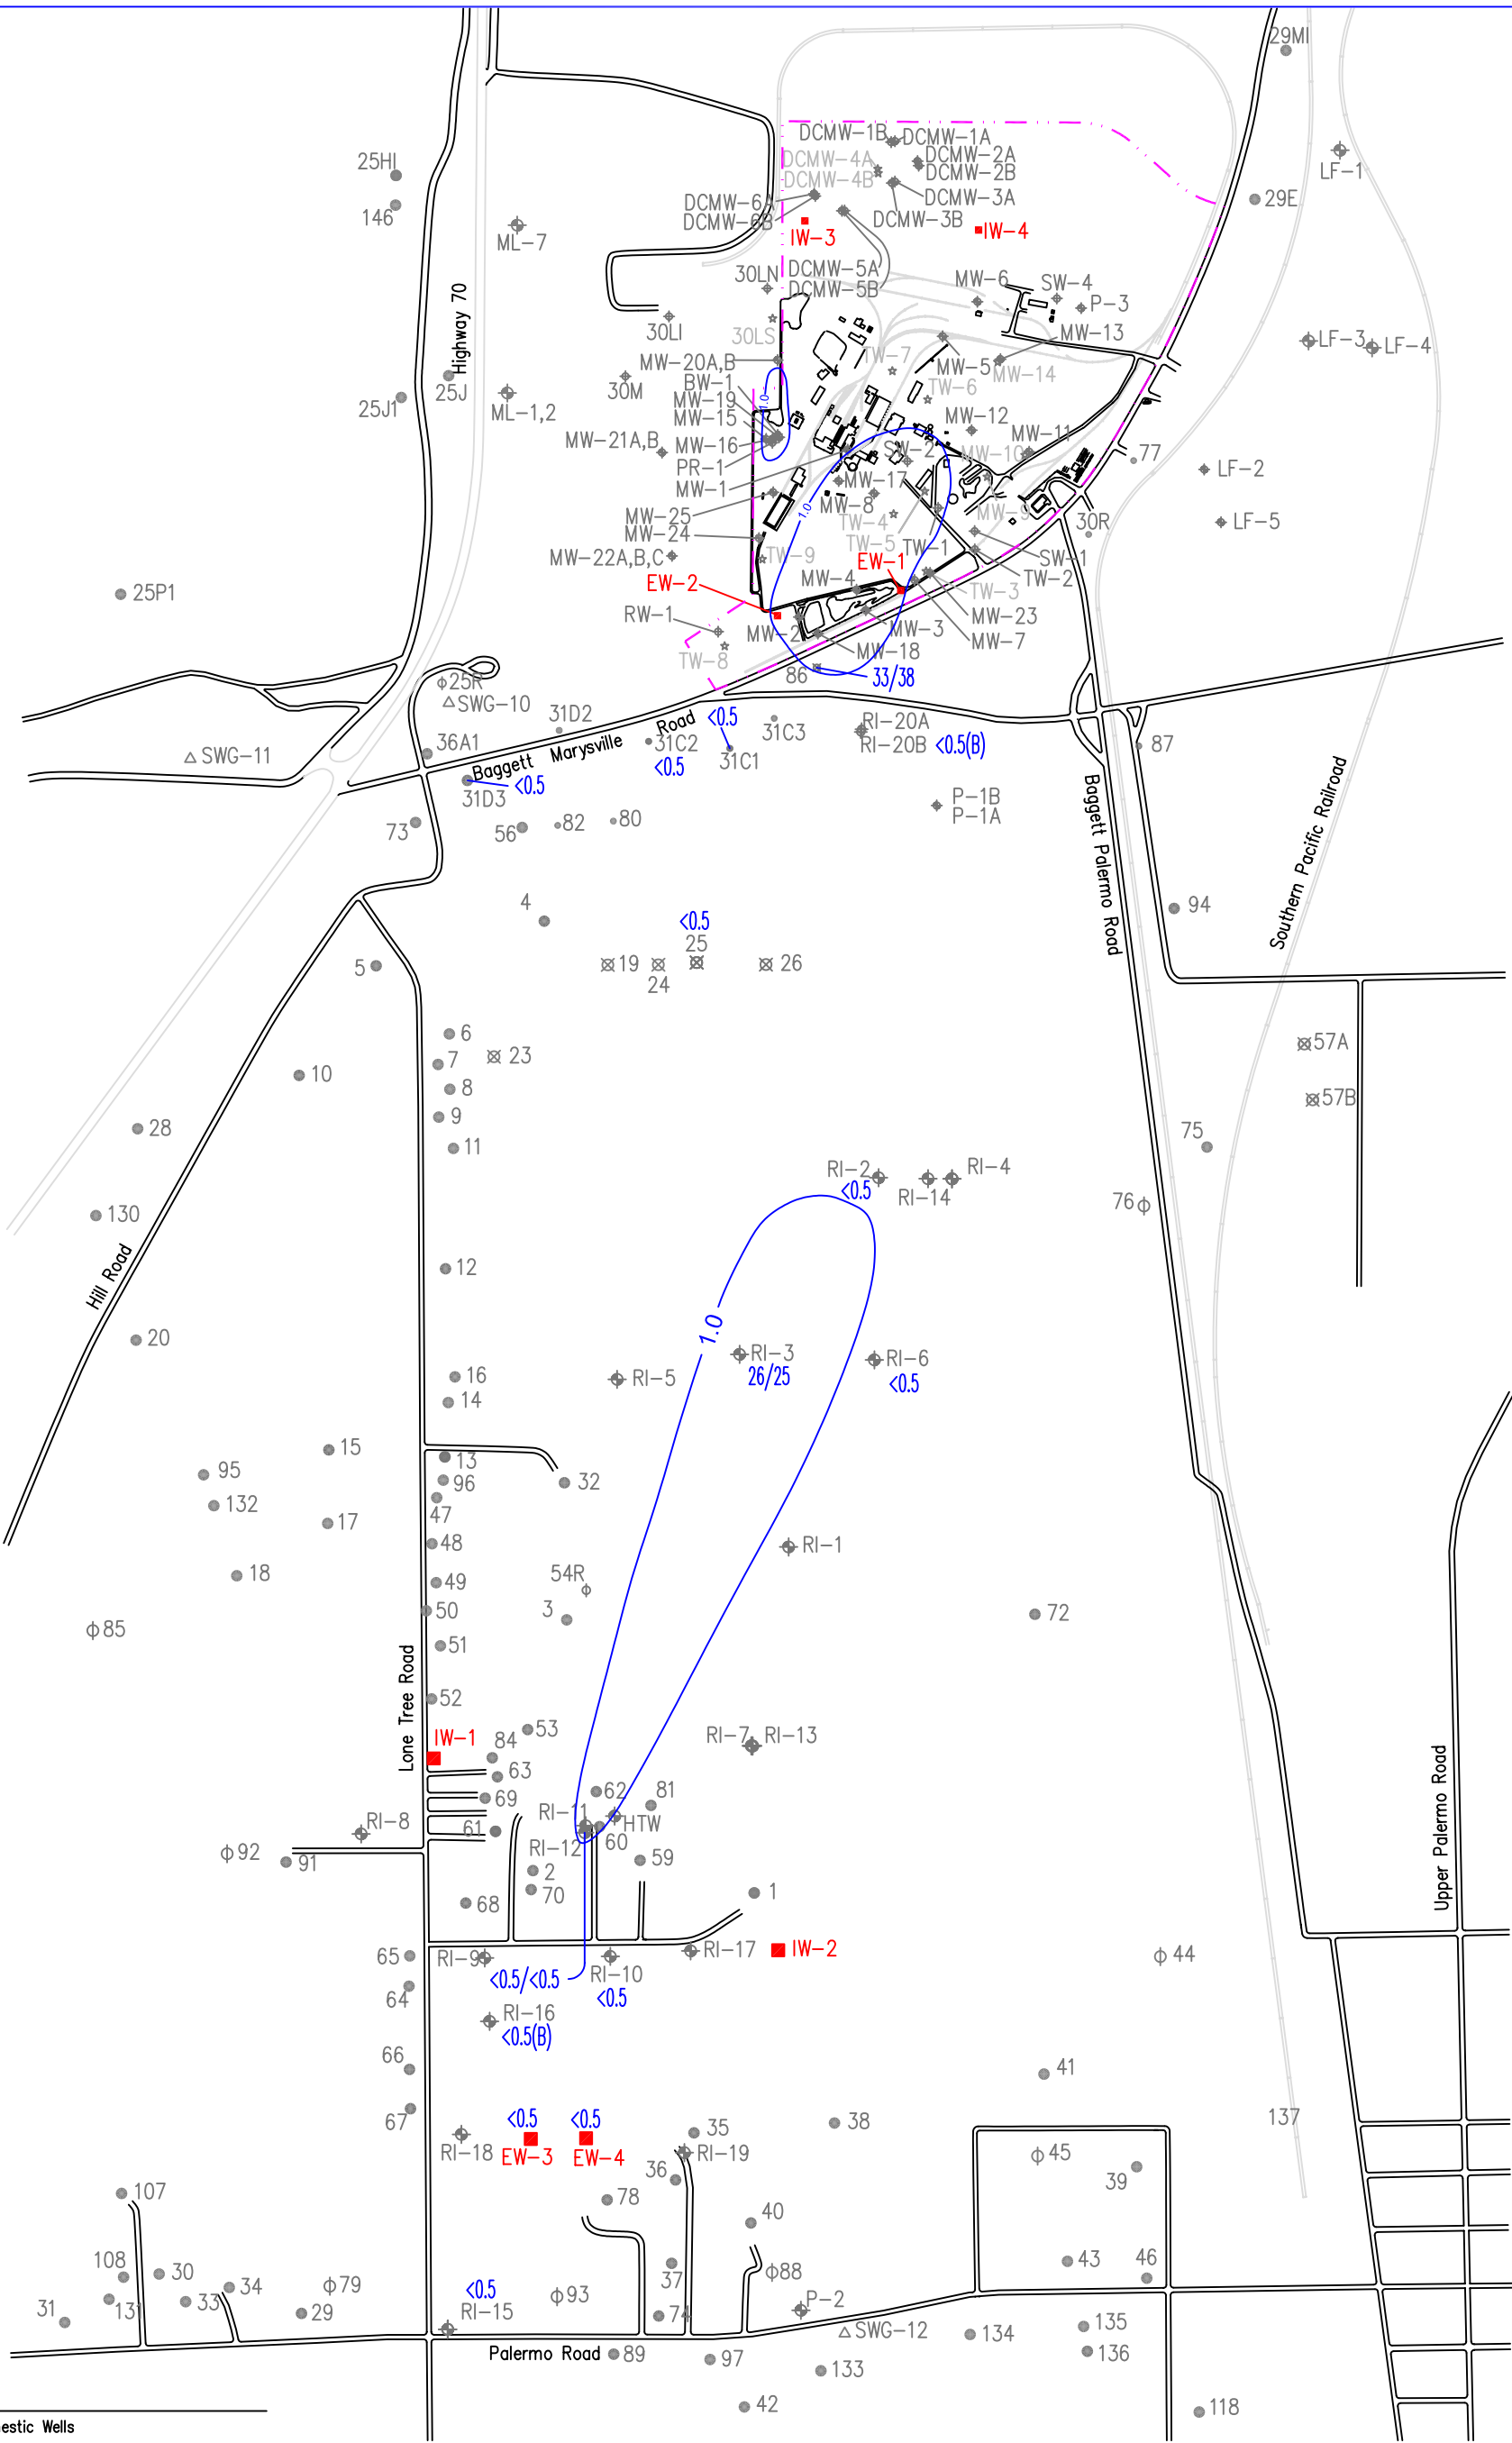
- EXPLANATION
- Domestic Wells
  - ⊕ Industrial Wells
  - ⊕ Irrigation and Stock Wells
  - ⊗ Unused Wells
  - ⊕ Monitoring, Test and Remedial Investigation Wells
  - △ Surface Water Gauge
  - ☆ Destroyed Wells
  - Extraction and Injection Wells
  - Property Boundary

—1.0— Pentachlorophenol Concentration ( $\mu\text{g/L}$ ) in Groundwater May/June 2002
